TECHNICAL REFERENCE

Mosul Dam Rehabilitation Project

Drilling & Grouting

Civil & Hydromechanical Works

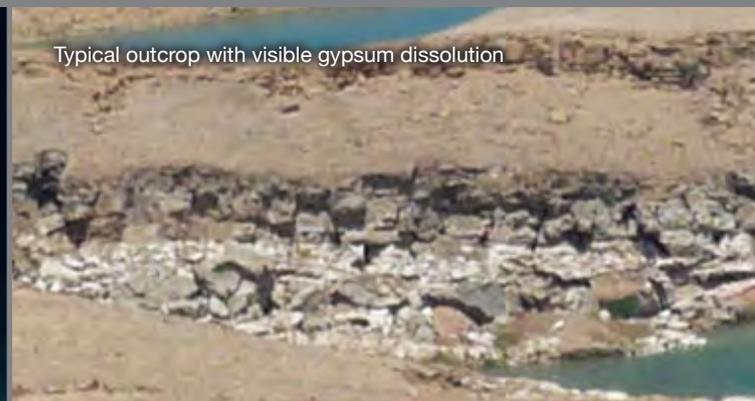
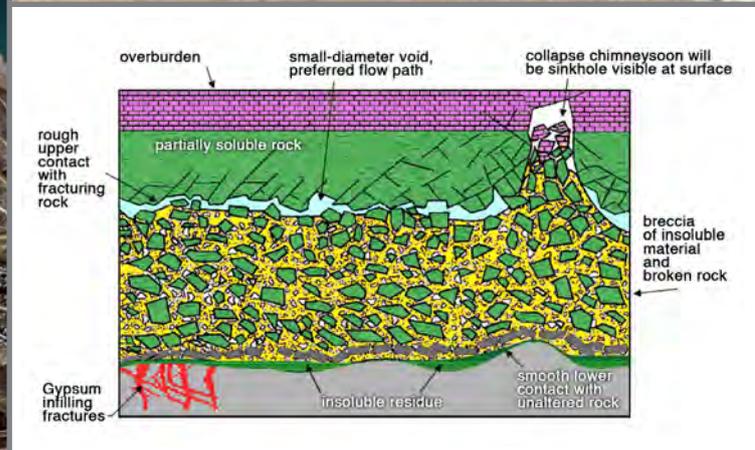
Typical outcrop with visible gypsum dissolution

The dam is founded on a layered sequence of rocks including marls, chalky limestone, gypsum, anhydrite, and limestone. A feature of the geology is the occurrence of karstic limestone and the development of solution cavities within the gypsum and anhydrite layers. Dissolution phenomena result in the formation of fissures and voids that allow considerable water percolation, due to the strong hydraulic gradient imposed by the Dam. The karst development extends to a depth of 100 m below the dam's foundation.
